**Flood Control Project Maintenance
Levee Inspections**

Fall 2011 Levee Maintenance Deficiency Summary Report

Sacramento River Basin

Sacramento River West Side Levee District

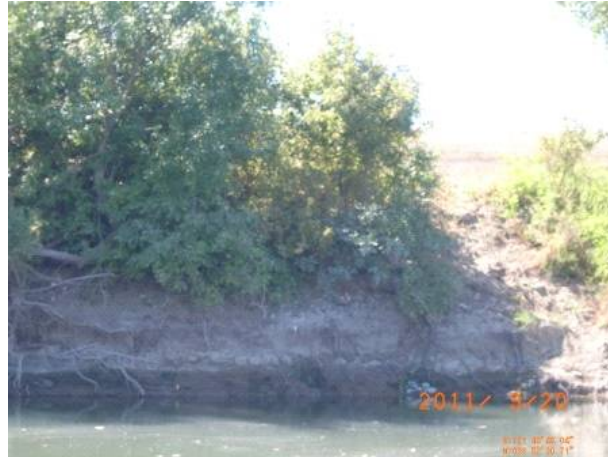
USACE 2011 Photo #2

Levee Mile Report Line	11
Start Levee Mile	10.03
End Levee Mile	11.51
Location	Water Side
Category	Supplemental
Item	USACE Erosion Survey

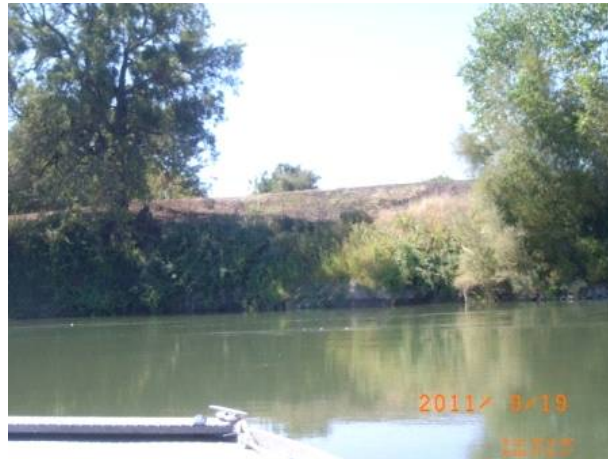
USACE 2011 Photo #1

Levee Mile Report Line	17
Start Levee Mile	18.84
End Levee Mile	18.84
Location	Water Side
Category	Supplemental
Item	USACE Erosion Survey

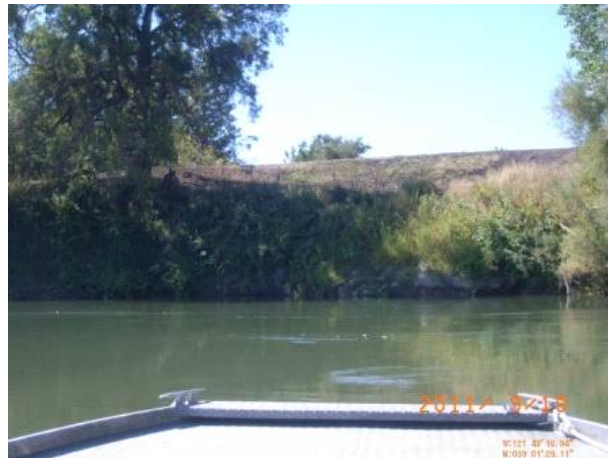
USACE 2011 Photo #2

Levee Mile Report Line	17
Start Levee Mile	18.84
End Levee Mile	18.84
Location	Water Side
Category	Supplemental
Item	USACE Erosion Survey

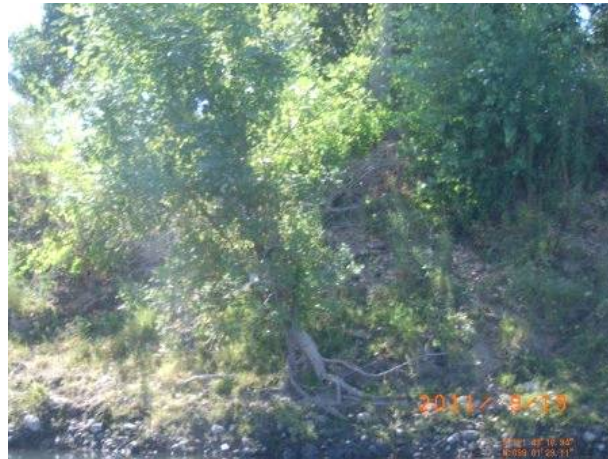
USACE 2011 Photo #1

Levee Mile Report Line	30
Start Levee Mile	23.69
End Levee Mile	23.69
Location	Water Side
Category	Supplemental
Item	USACE Erosion Survey

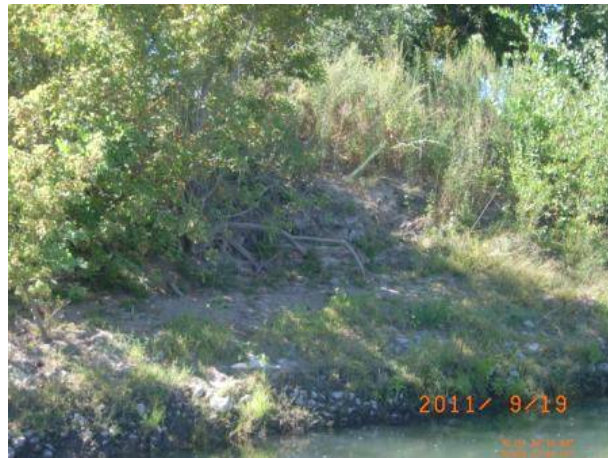
USACE 2011 Photo #2

Levee Mile Report Line	30
Start Levee Mile	23.69
End Levee Mile	23.69
Location	Water Side
Category	Supplemental
Item	USACE Erosion Survey

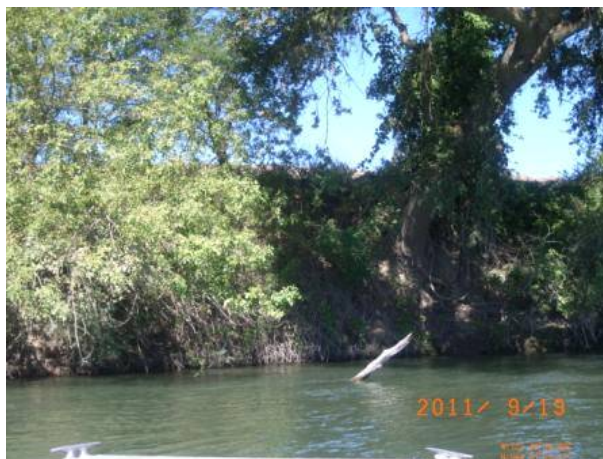
USACE 2011 Photo #2

Levee Mile Report Line	32
Start Levee Mile	25.91
End Levee Mile	25.91
Location	Water Side
Category	Supplemental
Item	USACE Erosion Survey

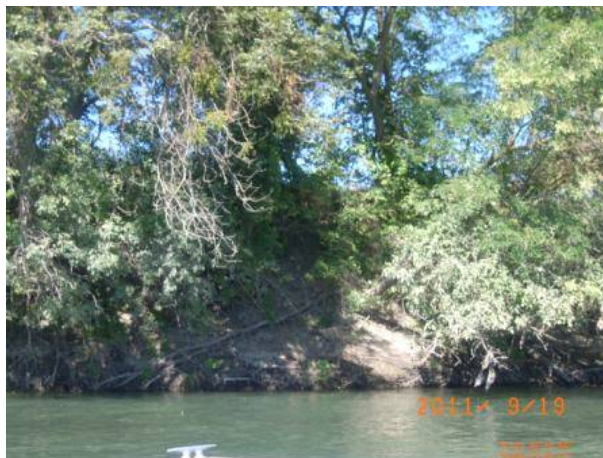
USACE 2011 Photo #3

Levee Mile Report Line	32
Start Levee Mile	25.91
End Levee Mile	25.91
Location	Water Side
Category	Supplemental
Item	USACE Erosion Survey

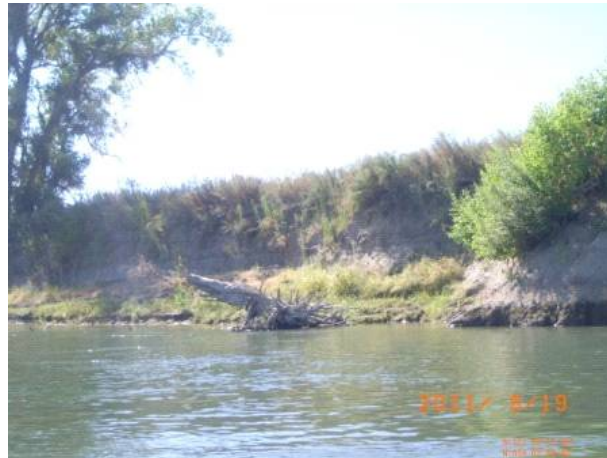
USACE 2011 Photo #1

36	29.98	29.98	Supplemental	USACE Erosion Survey	WS	M	Inspector Comments: 1997 - Mass failure of the lower cohesive bank and toe. 2000 - Still eroding, steeply dipping foresets in the toe are falling off. 2010 - Some new erosion and some new deposition. Eddy current off the upstream rock. 2011: Still plenty of berm left. [2011 Site ID: SAC_122-0_R]	39.063209 ° -121.838927 °	39.063997 ° -121.839335 °	10 Y
37	30.21	30.21	Supplemental	USACE Erosion Survey	WS	M	Inspector Comments: 2002 - Upstream end has recent slope failure and exposure of tree roots. 2003 - Some new minor slope erosion with new snags on the bank. 2004 - Appears a little worse. 2005 - Scallop in bank at the upstream end looks worse. 2009 - Minimal new erosion, Berm width is still large, but one large event or one fallen tree and it could go fast. 2010 - New erosion, bank is nearly all vertical from slumping. Site looks bad. 2011: site starting to look bad. [2011 Site ID: SAC_122-3_R]	39.065886 ° -121.842950 °	39.066287 ° -121.843602 °	11 Y

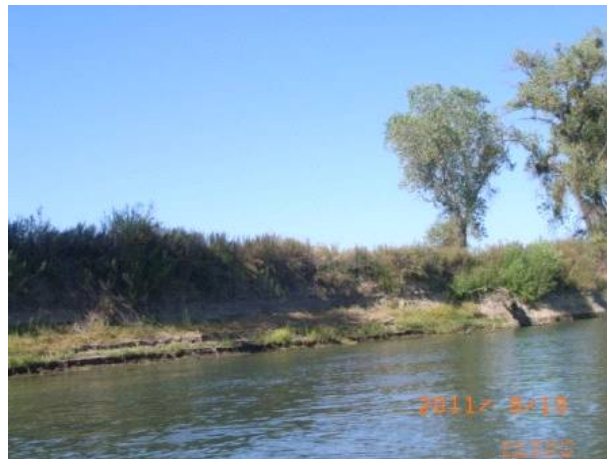
USACE 2011 Photo #2

Levee Mile Report Line	37
Start Levee Mile	30.21
End Levee Mile	30.21
Location	Water Side
Category	Supplemental
Item	USACE Erosion Survey

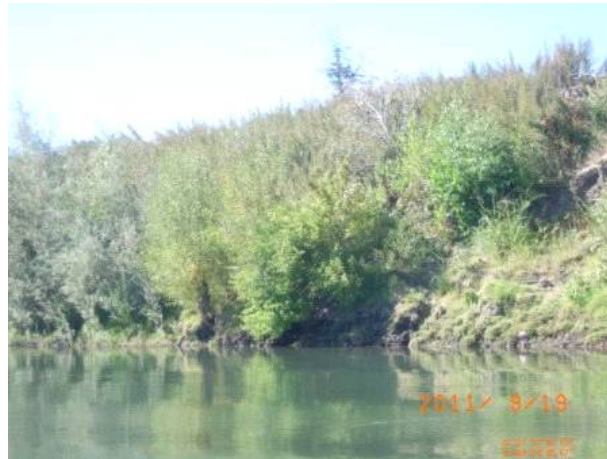
USACE 2011 Photo #3

Levee Mile Report Line	44
Start Levee Mile	33.64
End Levee Mile	33.64
Location	Water Side
Category	Supplemental
Item	USACE Erosion Survey

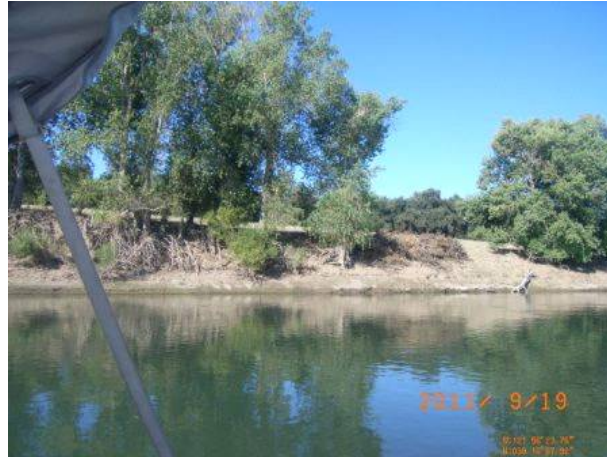
USACE 2011 Photo #1

46	35.62	35.62	Supplemental	USACE Erosion Survey	WS	M	Inspector Comments: 1997 - Major scour off the downstream end of existing rock, creating a scour pocket where the levee starts diverging from the bankline. 2000 - Some minor erosion, 20 ft deep hole at downstream end. 2004 - Small amount of new erosion. 2010 - Bad transition off downstream end of rock revetment, some new erosion. 2011: No observed change. [2011 Site ID: SAC_127-9_R]	39.100084 ° -121.903981 °	39.100836 ° -121.904320 °	17 Y
47	42.85	43.02	Earthen Levee	Vegetation	LS	M	Remove the wild growth other than native grasses from the levee slopes. Inspector Comments: Johnson grass is progressing and is getting densier.	39.164373 ° -121.936867 °	39.166666 ° -121.937674 °	1430 Y
48	43.35	43.35	Supplemental	USACE Erosion Survey	WS	M	Inspector Comments: 2010 - Lower portion of 136.7 that did not extend far enough. Abrupt transition from upstream site. 2011: No observed change. [2011 Site ID: SAC_136-6_R]	39.173245 ° -121.939419 °	39.174555 ° -121.940427 °	19 Y

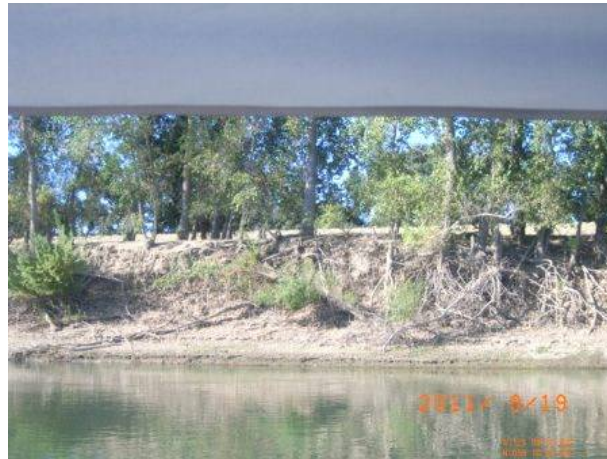
USACE 2011 Photo #2

Levee Mile Report Line	48
Start Levee Mile	43.35
End Levee Mile	43.35
Location	Water Side
Category	Supplemental
Item	USACE Erosion Survey

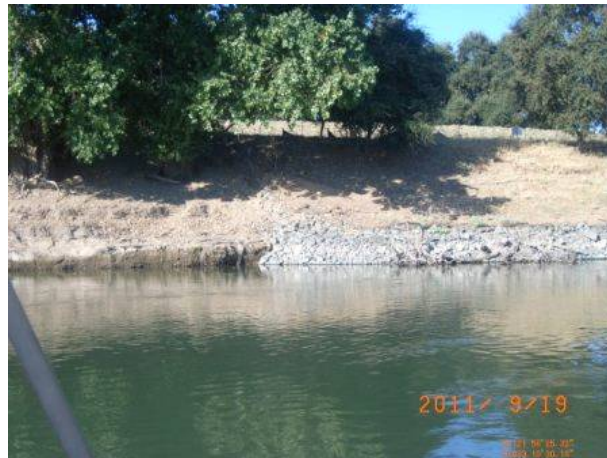
USACE 2011 Photo #3

Levee Mile Report Line	48
Start Levee Mile	43.35
End Levee Mile	43.35
Location	Water Side
Category	Supplemental
Item	USACE Erosion Survey

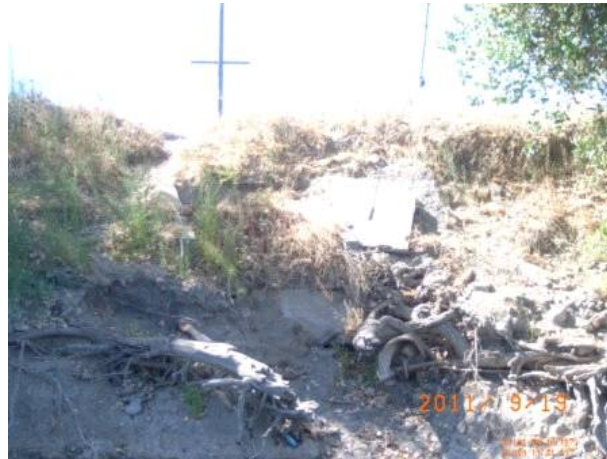
USACE 2011 Photo #2

Levee Mile Report Line	57
Start Levee Mile	48.11
End Levee Mile	48.11
Location	Water Side
Category	Supplemental
Item	USACE Erosion Survey

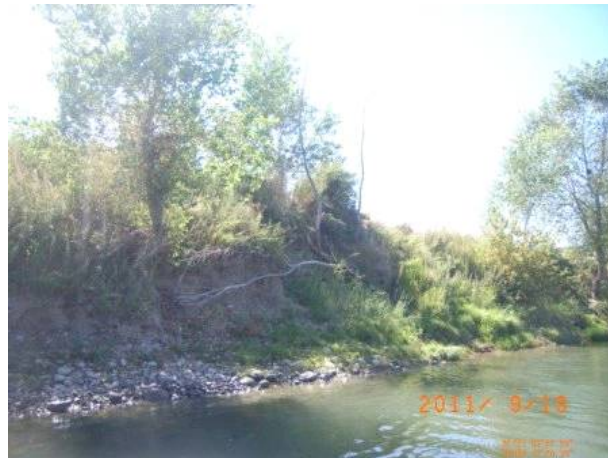
USACE 2011 Photo #2

Levee Mile Report Line	61
Start Levee Mile	50.03
End Levee Mile	50.03
Location	Water Side
Category	Supplemental
Item	USACE Erosion Survey

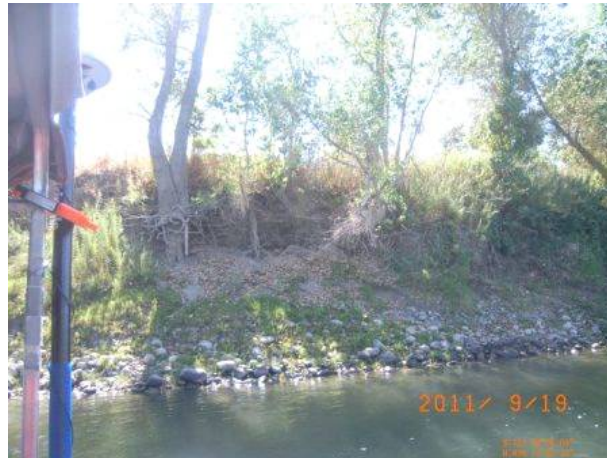
Levee Mile Report Line	61
Start Levee Mile	50.03
End Levee Mile	50.03
Location	Water Side
Category	Supplemental
Item	USACE Erosion Survey
USACE 2011 Photo #3	
USACE2011_SAC_143-5_R_3.jpg
